INFRARED THERMOGRAPHY

Gerlach Nathalie

NDT method for aerospace composites

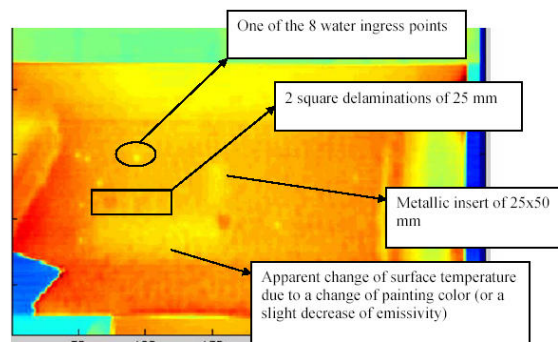
Fig.4 Time averaging IR image showing 8 water ingress points and 3 square delaminations

Then a complete signal processing is studied using time based information, spatial filtering and finally advanced post processing using automatic defect detection algorithm.
